# Natural Channel Design and its Application to Daniels Run, Fairfax, Virginia

*Stream Habitat Assessment and  
Restoration Program  
Chesapeake Bay Field Office  
U.S. Fish and Wildlife Service*

# Daniels Runs Stream Restoration Project

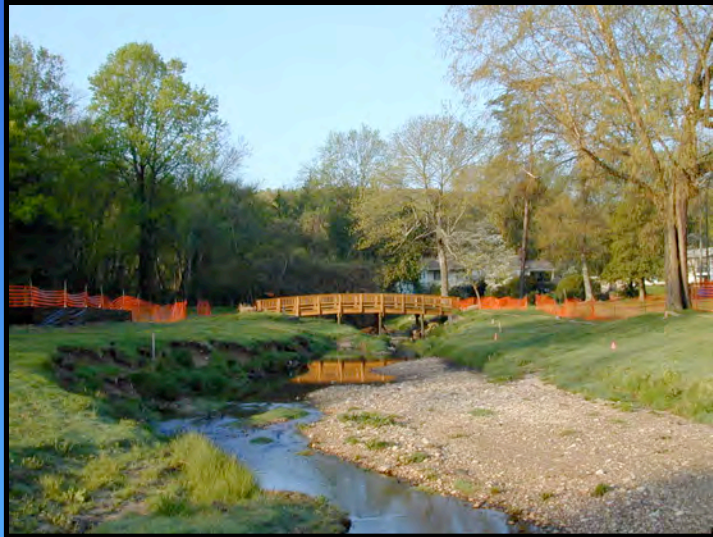
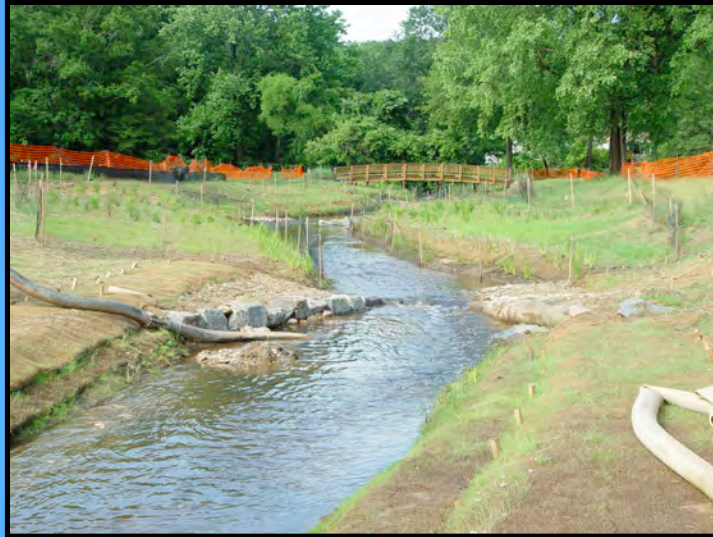
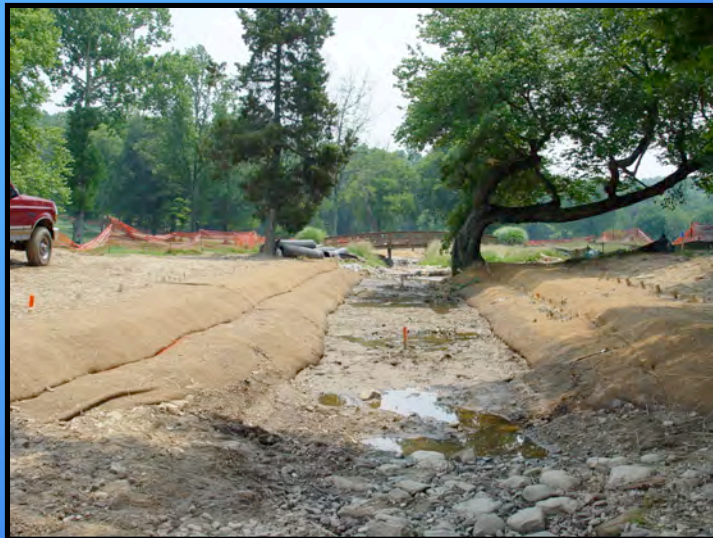
# Daniels Run Stream Restoration Before and After

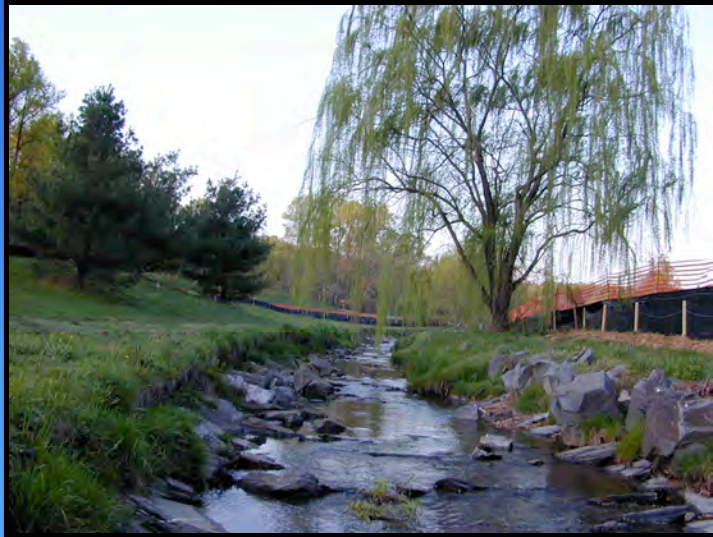
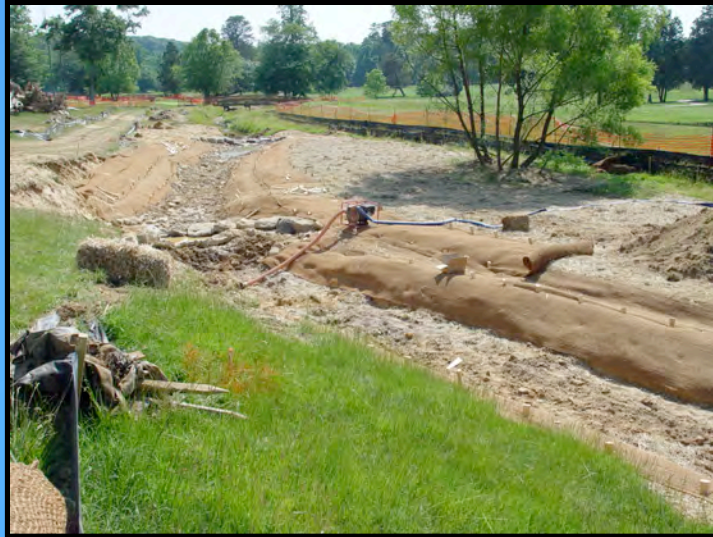
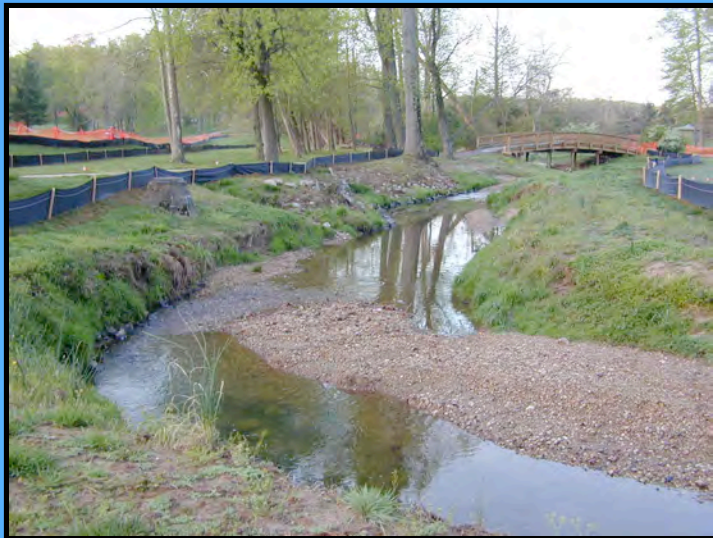
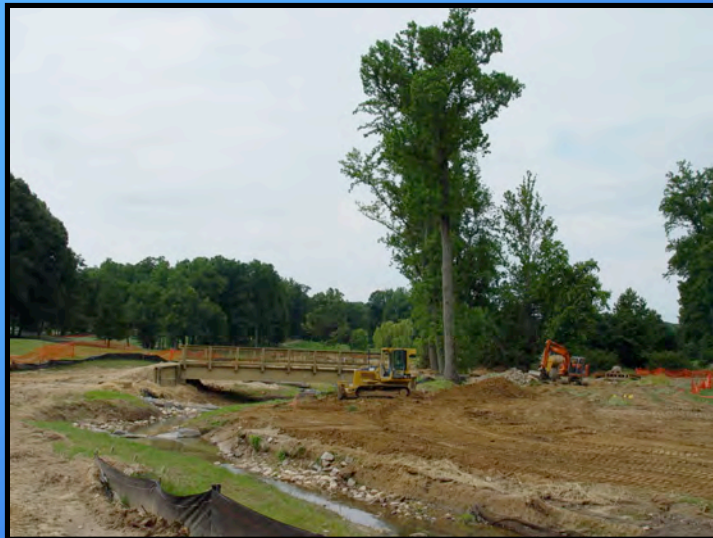
# Daniels Run Stream Restoration Before and After
